Incident Report:

# Walked Away Without Injury

**LIVE ARC FLASH  
CAUGHT ON CAMERA**

## Industrial Arc Flash — Accident Investigation Report #21014

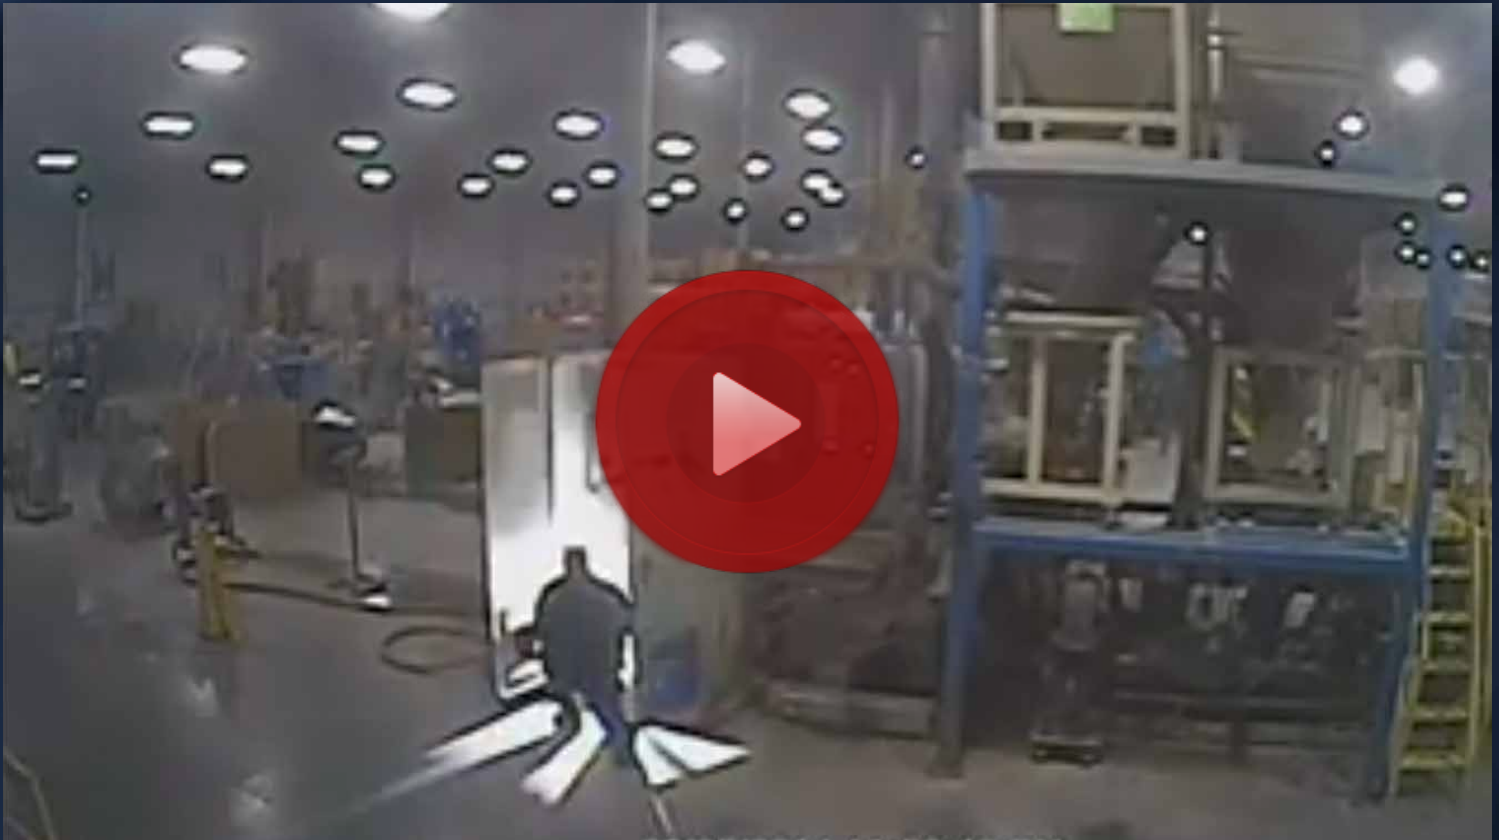
The incident energy produced by the arc flash, estimated to be approximately 5 cal/cm<sup>2</sup>, hit the employee, who was approximately 20" away from the arc gap. While the employee was temporarily blinded from the intense light energy emitted from the flash, no tissue damage or burns occurred.

*Our investigation determined that the root cause of this arc flash was the failure of a 30 amp fuse located in a common fuse housing. The fuse failure, and the accumulation of dust on the conductors, caused a cascading event across the entire fuse housing.*

Note: On the security camera image (above) the maintenance employee failed to establish an arc flash boundary.

Ensure all knockouts and other openings are properly closed on all electrical enclosures to minimize the accumulation of dust, and

Ensure that the doors of the electrical enclosures properly close and latch, and

Ensure that all qualified employees, who perform live electrical tasks, establish an arc flash boundary (e.g. caution tape, etc.) to minimize the risk of injury to fellow employees.

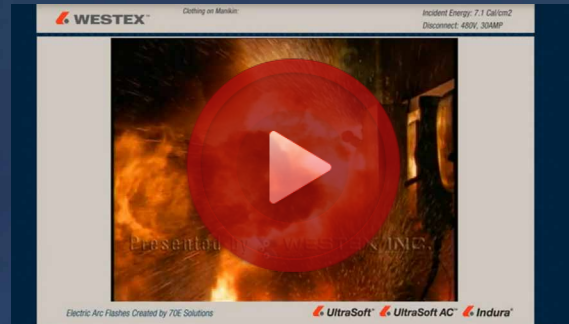
**Arc Flash 7.1 cal** — Slow-motion test footage depicts an arc flash similar in nature to the one described in this accident investigation report.
